**Test
Report**

Our Ref: GBW Number 132579 Issue 1 Date 30/03/2015 Page 1 of 8

SALT SPRAY TESTING OF GALVANISED STEEL PLATE / TUBE ASSEMBLY SAMPLE

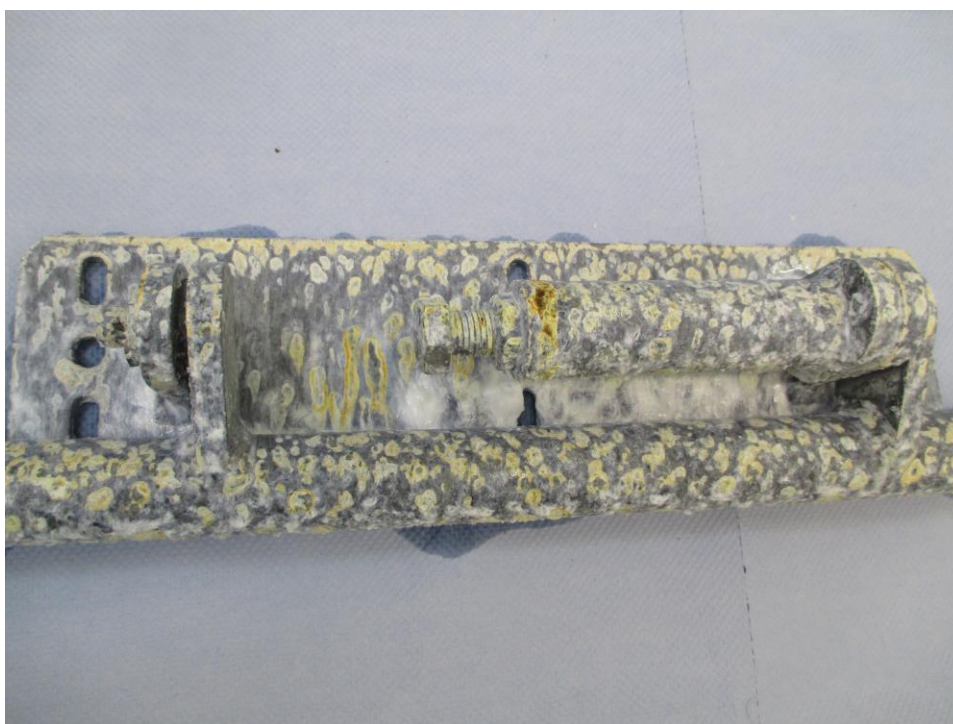
The sample showed a small area of red ferrous corrosion on the tube arm adjacent to the nut and a significant amount small spots of red ferrous corrosion 1.0mm maximum size and significant yellow corrosion product and total white zinc corrosion (see photograph after 240 hours).

Fig 4: Photograph showing the condition of the Sample after 240 hours Salt Spray Test

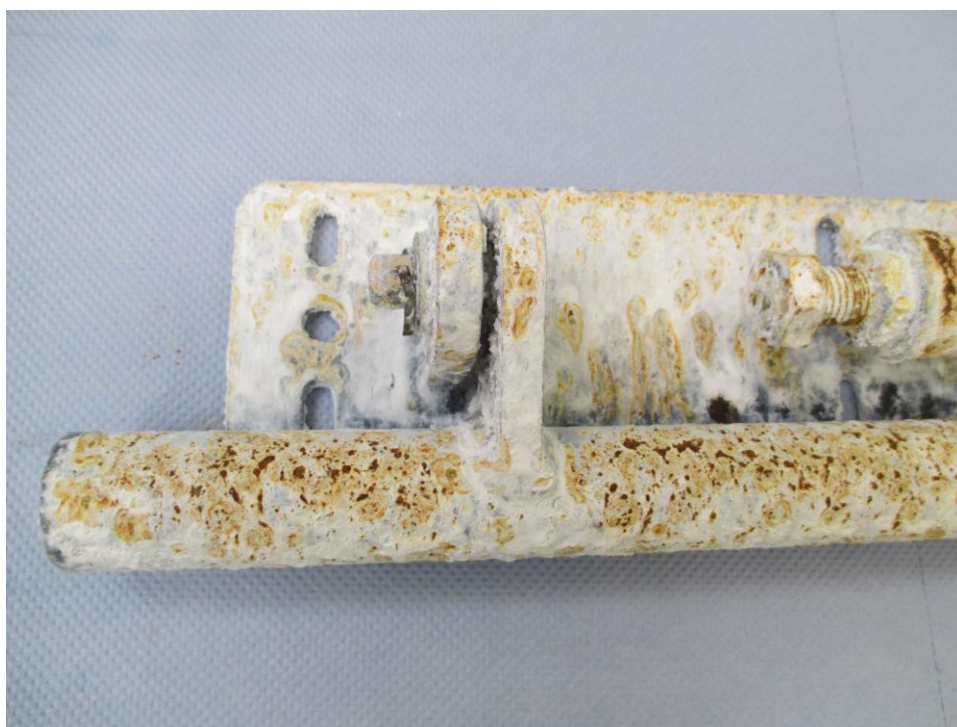
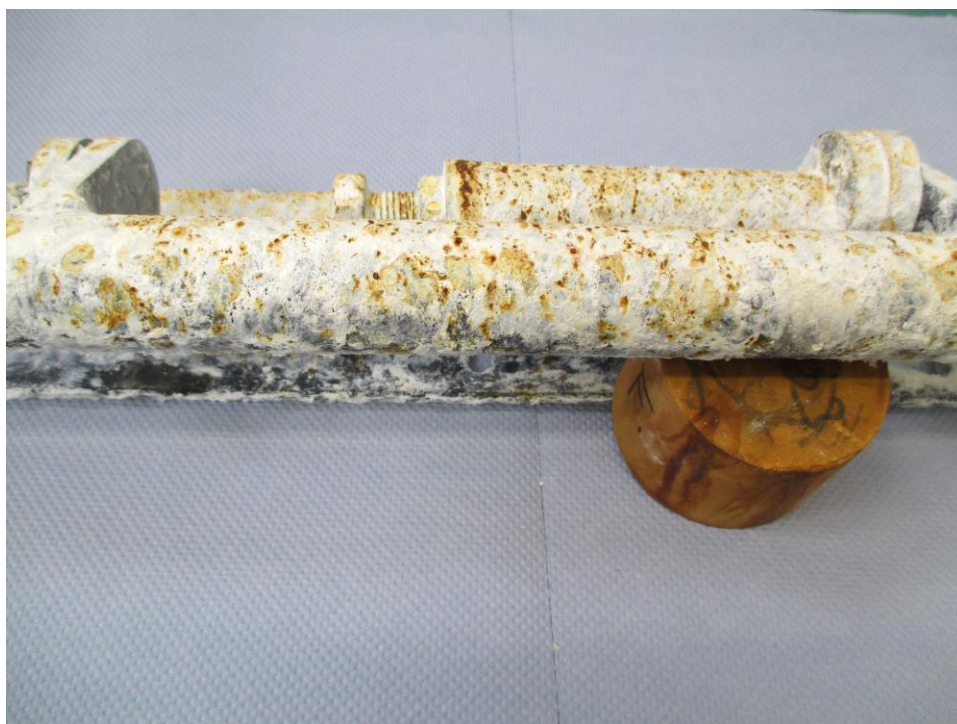
The sample showed an area of red ferrous corrosion on the tube arm adjacent to the nut and small area on the left hinge.

The general condition of the sample showed a significant amount of small spots of red ferrous corrosion 3.0mm maximum size and a significant amount of yellow corrosion product and total white zinc corrosion, the spring tension mechanism function worked satisfactory (see photographs).

The finish applied to the Galvanised Steel / Tube Assembly Sample tested, **failed to withstand** 672 hours Salt Spray Test requirement without the formation of red ferrous corrosion.

Fig 7: Photograph showing the condition of the Sample after 672 hours Salt Spray Test

Fig 8: Photograph showing the condition of the Sample after 672 hours Salt Spray Test

Fig 9: Photograph showing the condition of the Sample after 672 hours Salt Spray Test
